PHASE I INSPECTION REPORT **2 NATIONAL DAM SAFETY PROGRAM**

NAME OF DAM: SOUTH RIVER NO. 25

Stream: Toms Branch Back Creek
Date of Inspection: 12 July 1978

PHASE I INSPECTION REPORT NATIONAL DAM SAFETY PROGRAM NAME OF DAM: SOUTH RIVER NO. 25 ID# VA 01502

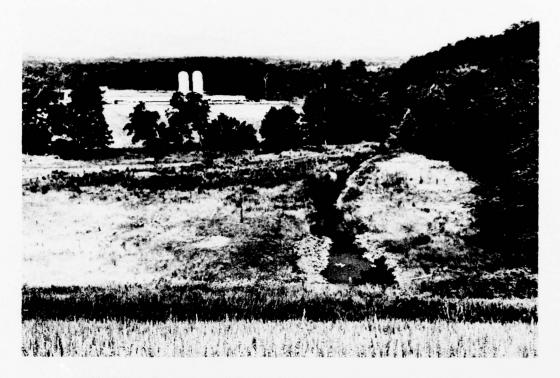
PHOTO 1. Downstream Channel From Principal Spillway and Farm

VISUAL EXAMINATION OF	ON OF OBSERVATIONS	REMARKS OR RECOMMENDAT
CONDITION (OBSTRUCTIONS, DEBRIS, ETC.)	The channel is in good condition with a bottom of gravel, cobbles and small boulders. No obstructions or debris were observed.	
SLOPES	The channel slopes at about one percent. The overbanks are flat and 1000 to 2000 feet wide, and they gradually rise to the mountain tops in several areas.	
APPROXIMATE NO. OF HOMES AND POPULATION	The nearest downstream population center is the Town of Sherando which is located about 1.7 miles downstream. Most of the town is situated very close to the streambank elevation. The approximate population is 150. The downstream channel is rather shallow and rectangular in shape near the homes. There is a farm immediately downstream (see Photo 1).

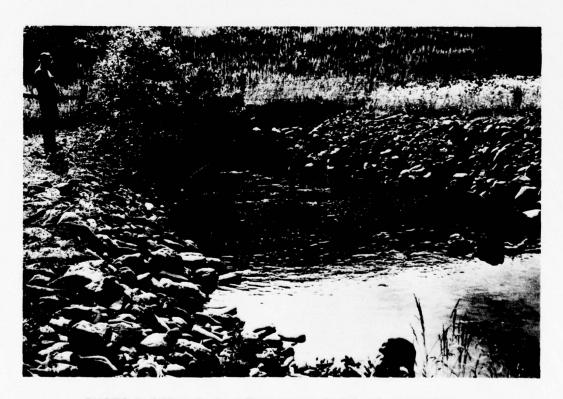
PHOTO 2. Stilling Basin at Downstream Outlet of Principal Spillway

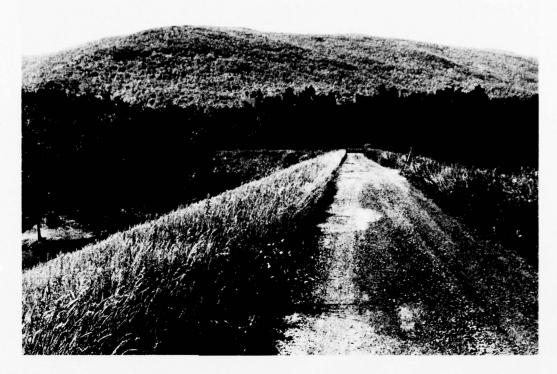
PHOTO 3. Curve of Dam on Left Side

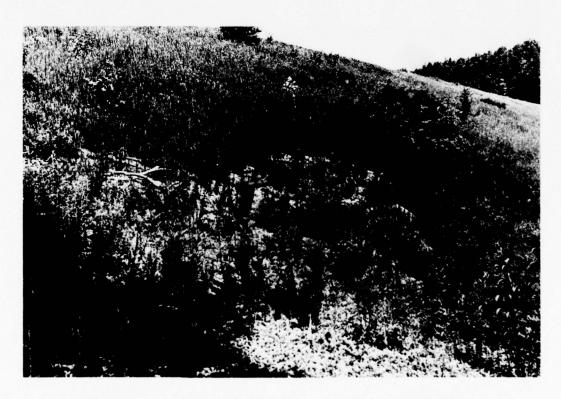
- Dam: The embankment was in good condition with no noticeable seepage. The ground cover was very heavy except on the downstream face, right abutment where there is slight erosion, and at the left abutment where leaves and wood debris have prevented growth. Trees and large bushes are growing at various places on the upstream and downstream face of the dam. Surface runoff in front of the left toe of the dam is being drained by existing tire tracks; consequently, large gullies are present.

PHOTO 4. Debris on Upstream Slope Near Curve on Left Side

3.2.1 Dam: The embankment is in good condition except for the trees, bushes and debris which should be removed. The eroded and sparsely vegetated areas on the upstream face near the abutments should be seeded and mulched.

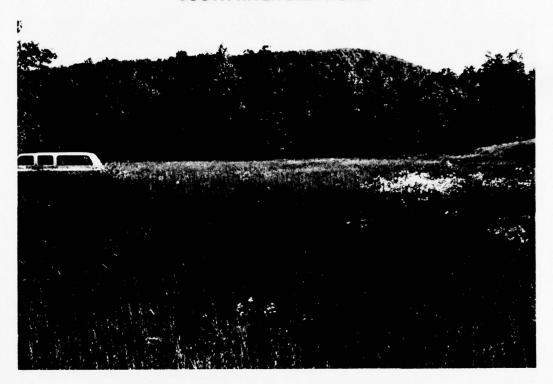
PHOTO 5. Upstream Portion of Emergency Spillway

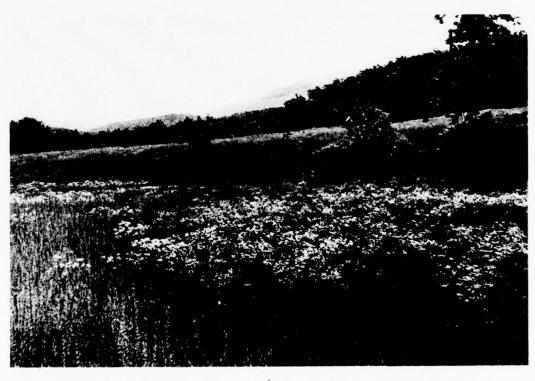
PHOTO 6. Cut Slope in Rock and Soil on Left Side of Emergency Spillway
With Borrow Area Beyond

The cut slope appears to be stable with minor talus accumula-

tion.
